# Product Change Notification

## 113329 - 00

**Change Notification #:** 113329 - 00  
**Change Title:** Intel® Server System R2308GZ4GS9  
PCN 113329-00, Product Design  
Update the System Rear Panel, Resistors,  
Capacitors and BIOS/ME/BMC/FRUSDR  
Firmware  
**Date of Publication:** October 22, 2014

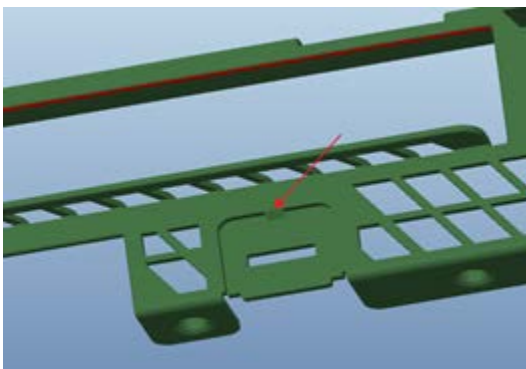
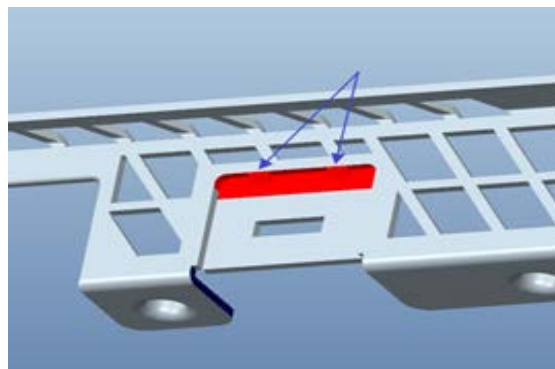
Figure One

1. Update the one big center joint to two smaller joints so that the joints will not conflict with the LAN cable connector latch. See the Figure One.

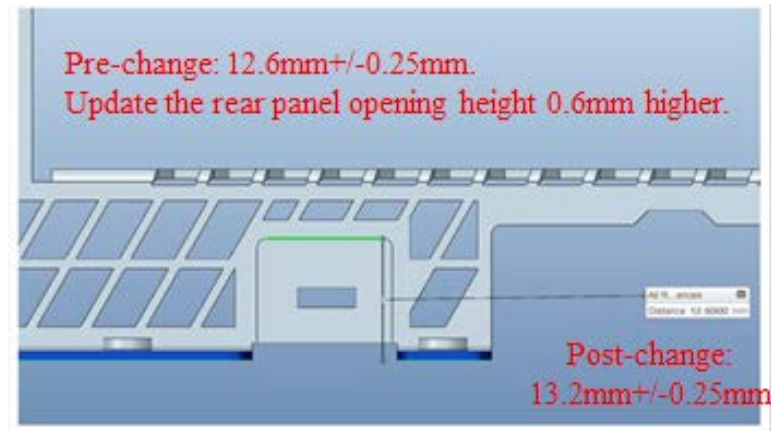
Figure Two

- Update the rear panel opening height 0.6mm higher to improve the flexibility for the cable latch. The previous height was 12.6mm $\pm$ 0.25mm. The updated height is 13.2mm $\pm$ 0.25mm. See the Figure Two.

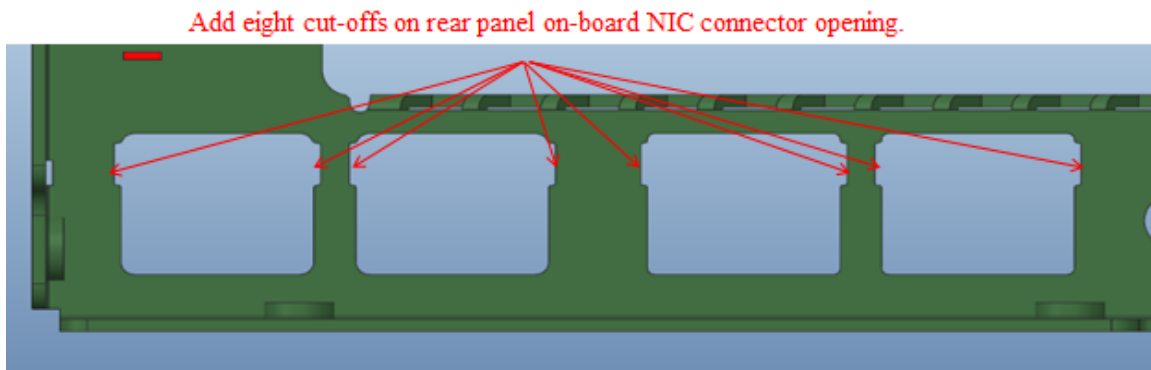
Figure Three

- Add eight cut-offs around the on-board NIC (Network Interface Controller) openings to improve the LED visibility. See the Figure Three.

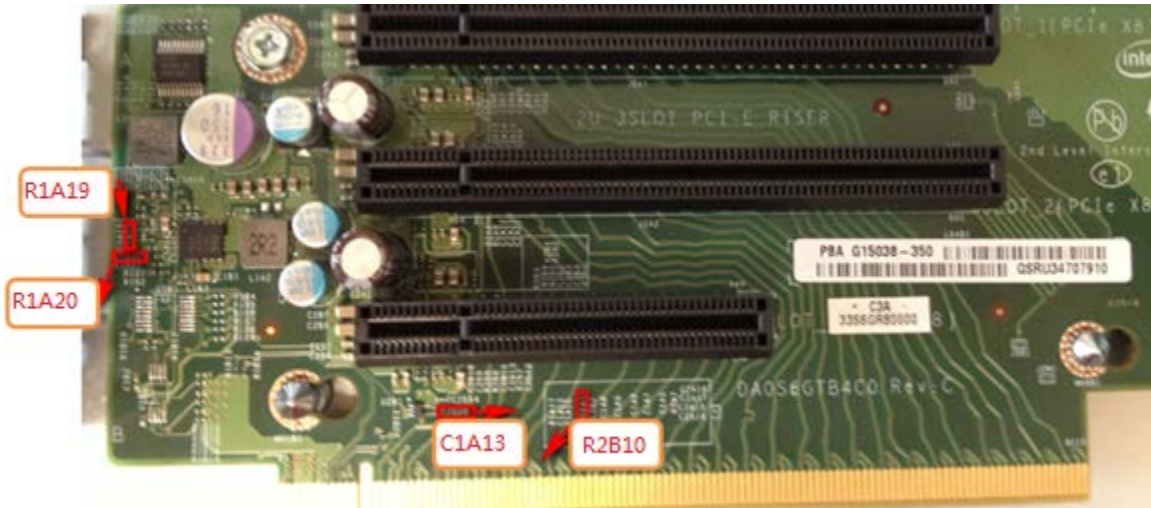
Figure Four. Component Locations for the 2U Riser Spare A2UL8RISER

- Update the following resistors and capacitor (see Table One and Figure Four) on the 2U PCIe Riser Spare A2UL8RISER to make an improvement to support a higher 3.3 Voltage Regulator startup over current. Before this change, the Voltage Regulator on the riser card may not be able to turn on when the total current drawn is more than 5A current. After this change, the Voltage Regulator on the riser card can support more than 10A current.
